UNDERWATER BRIDGE INSPECTION REPORT

STRUCTURE NO. 6610

MINNESOTA RIVER

MINNESOTA DEPARTMENT OF TRANSPORTATION
UNDERWATER BRIDGE INSPECTION

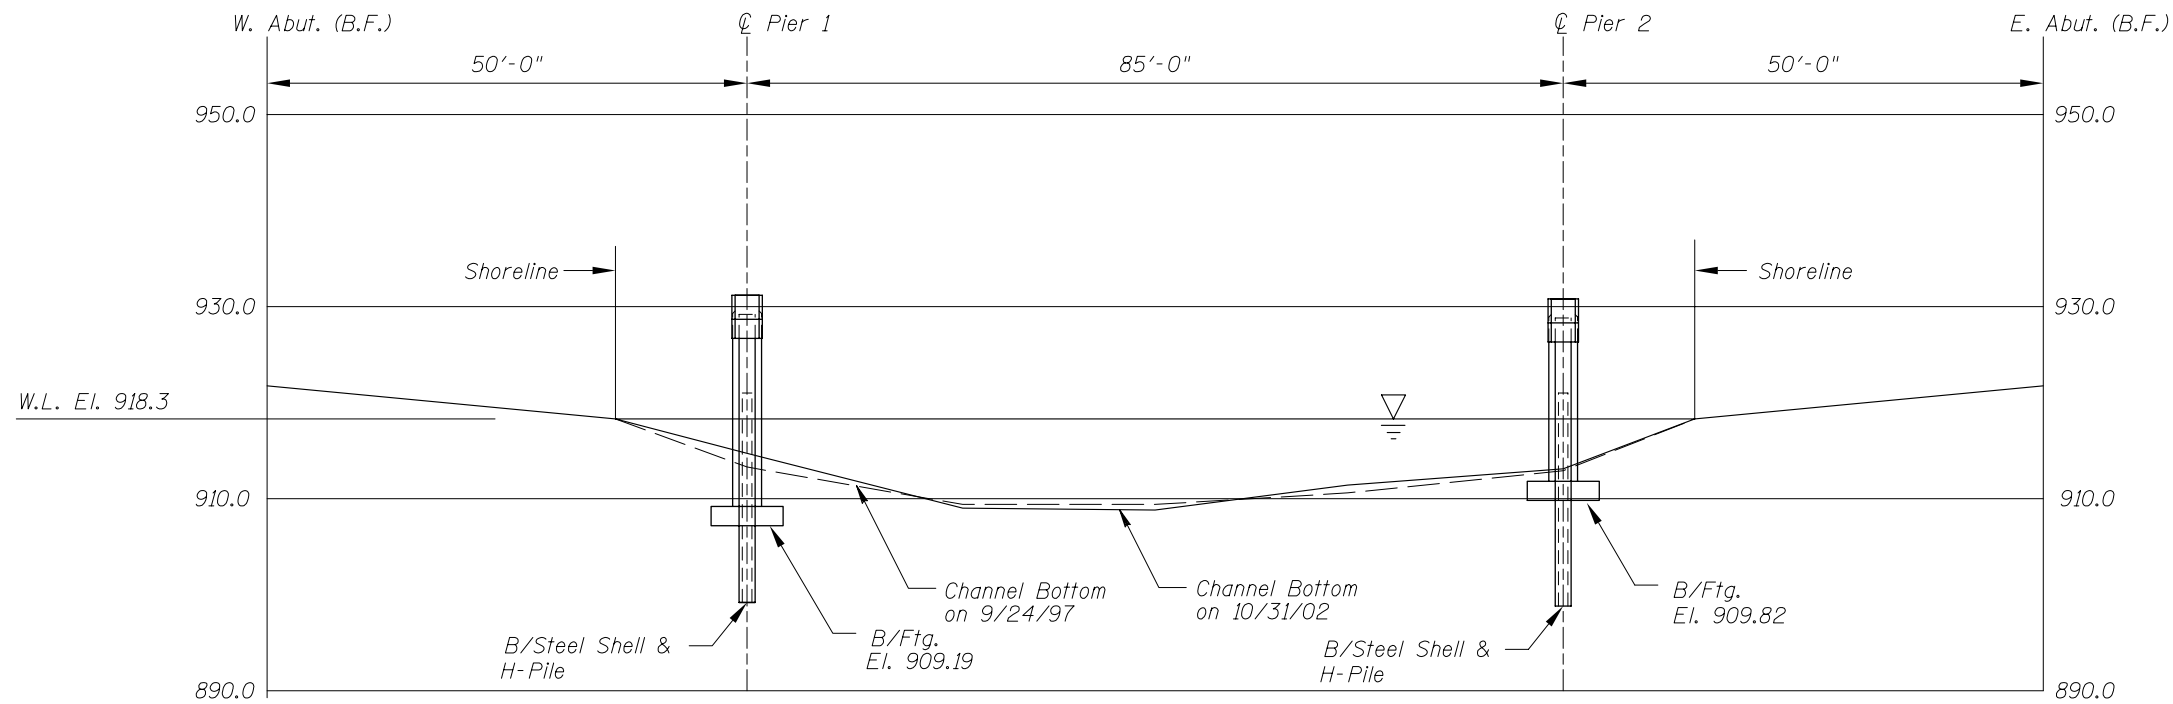
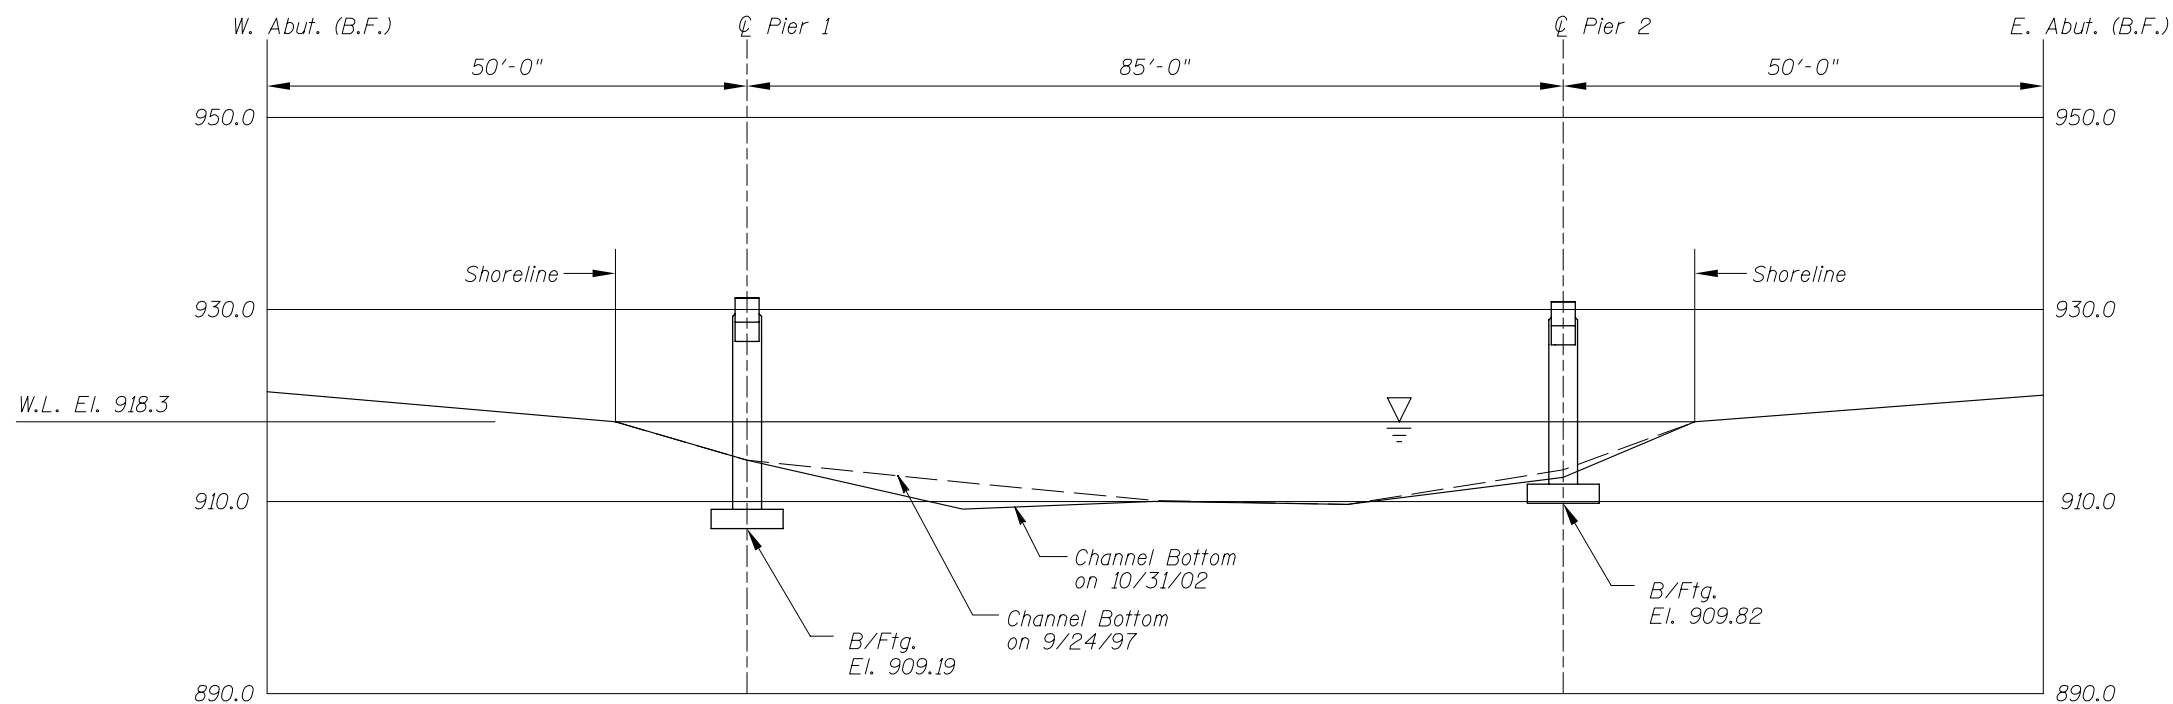
UPSTREAM FASCIA PROFILE

- 3 The footing was exposed at the west side at the downstream column of Pier 2 with a maximum vertical exposure of 3 inches.
- 4 A light area of section loss was observed 2 feet above the waterline at the downstream nose of Pier 1, measuring 3 square inches with 1 inch of penetration.

- 5 A light accumulation of timber debris, consisting of 6 to 8 inch diameter branches, was observed at the upstream nose of Pier 1 and extended along both sides of the pier.

- 6 A heavy accumulation of timber debris, consisting of up to 3 foot diameter timber logs, was observed at the upstream nose of Pier 2 and extended to the shoreline, and a light accumulation of timber debris extended along both sides of the pier.

- (A) Remove the accumulations of timber debris from the piers during routine maintenance to prevent further build-up and to restrict scour influence.
- (B) Because the bridge has been evaluated to be scour critical, specifically monitor the footing exposure during future inspections and after periods of high flows.
- (C) Reinspect the submerged substructure units at the normal maximum recommended (NBIS) interval of five (5) years.

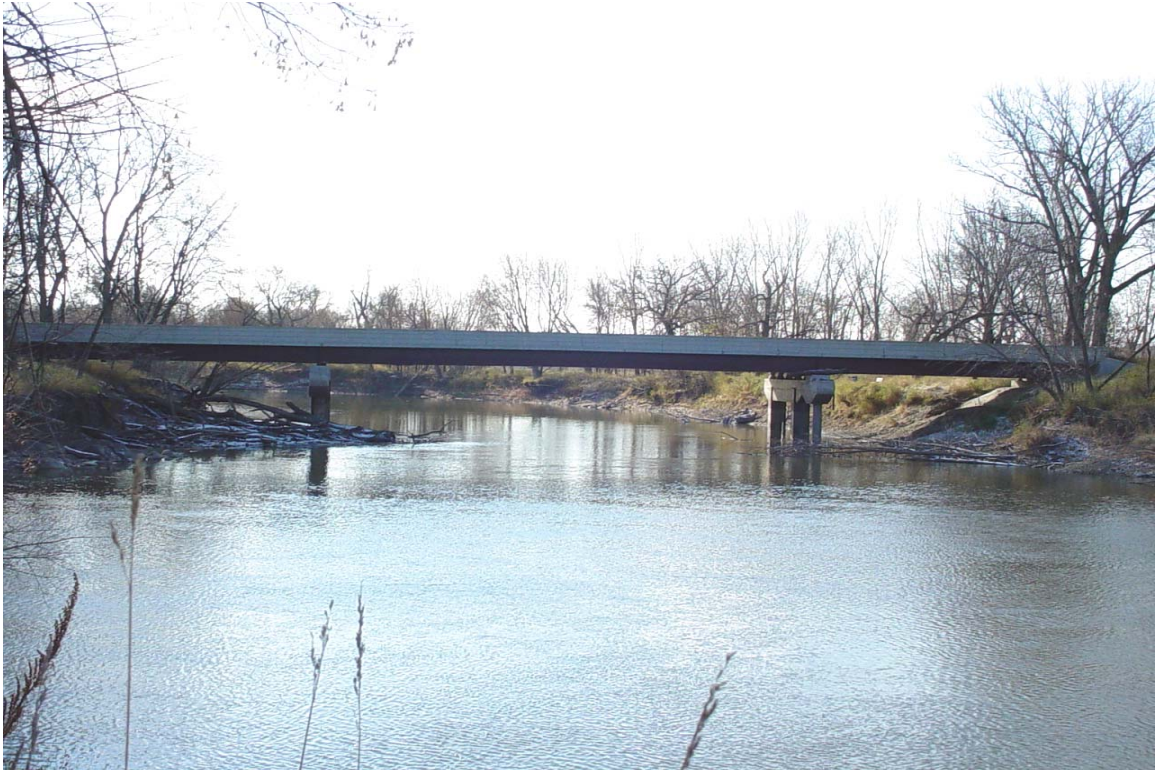
Photograph 1. Overall View of the Structure, Looking South.
